National Transportation Safety Board

Safety Recommendation

Date: April 7, 2000

In reply refer to: A-00-23 through -27

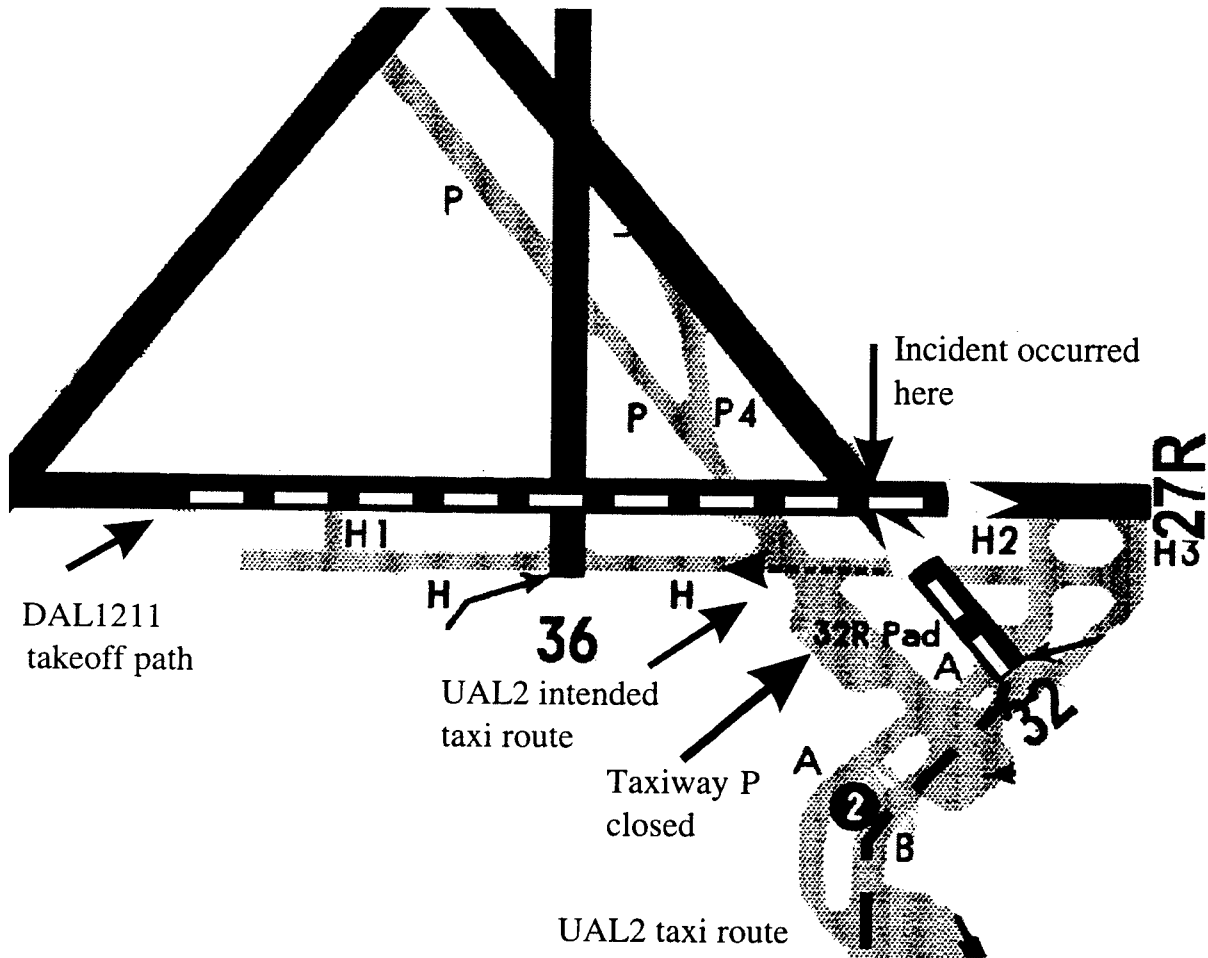
Figure 1. ORD Airport Diagram

Safety Board investigators found that the taxi route assigned for use between taxiways B and H at the time of the incident was not the taxi route usually assigned. Aircraft taxiing between taxiways B and H would normally follow taxiway P; however, a section of taxiway P had been closed for several weeks for reconstruction. The tower controllers elected to use runway 32R as a taxiway to bypass the closed section of taxiway P. The UAL2 crew was not familiar with that part of the route, and no signage identified taxiway H at its intersection with runway 32R.

The mechanic who was taxiing UAL2 stated that he was looking for a sign identifying taxiway H. Both crewmembers stated that the area was very dark and that they did not see any signs or lights identifying taxiway H. Thus, the absence of appropriate signage and markings at the runway 32R/taxiway H intersection apparently contributed to the loss of situational awareness experienced by the UAL2 crew, causing them to miss the turn onto taxiway H. This potential problem might have been detected and addressed if ORD's ATC managers had informed airport management about its alternate taxi plan and asked that the route be checked for adequate signage and markings. Detection and correction of such problems is important because, especially in unfamiliar situations, flight and ground crews depend on proper signs and surface markings to maintain situational awareness and avoid runway incursions. Therefore, the Safety Board believes that the FAA should amend FAA Order 7210.3, "Facility Operation and Administration," to require tower ATC managers to monitor planned airport construction projects or other activities that may require significant use of nonstandard taxi routes and coordinate with airport management to ensure that such routes are inspected for adequate signage and markings.

Amend Federal Aviation Administration Order 7210.3, "Facility Operation and Administration," to require tower air traffic control managers to monitor planned airport construction projects or other activities that may require significant use of nonstandard taxi routes and coordinate with airport management to ensure that such routes are inspected for adequate signage and markings. (A-00-28)
